Sentinel-1A Solar Array Impact

Benjamin Bastida Virgili, Holger Krag, ESA Space Debris Office

21/03/2017

Sentinel-1A Impact 2016/08/23

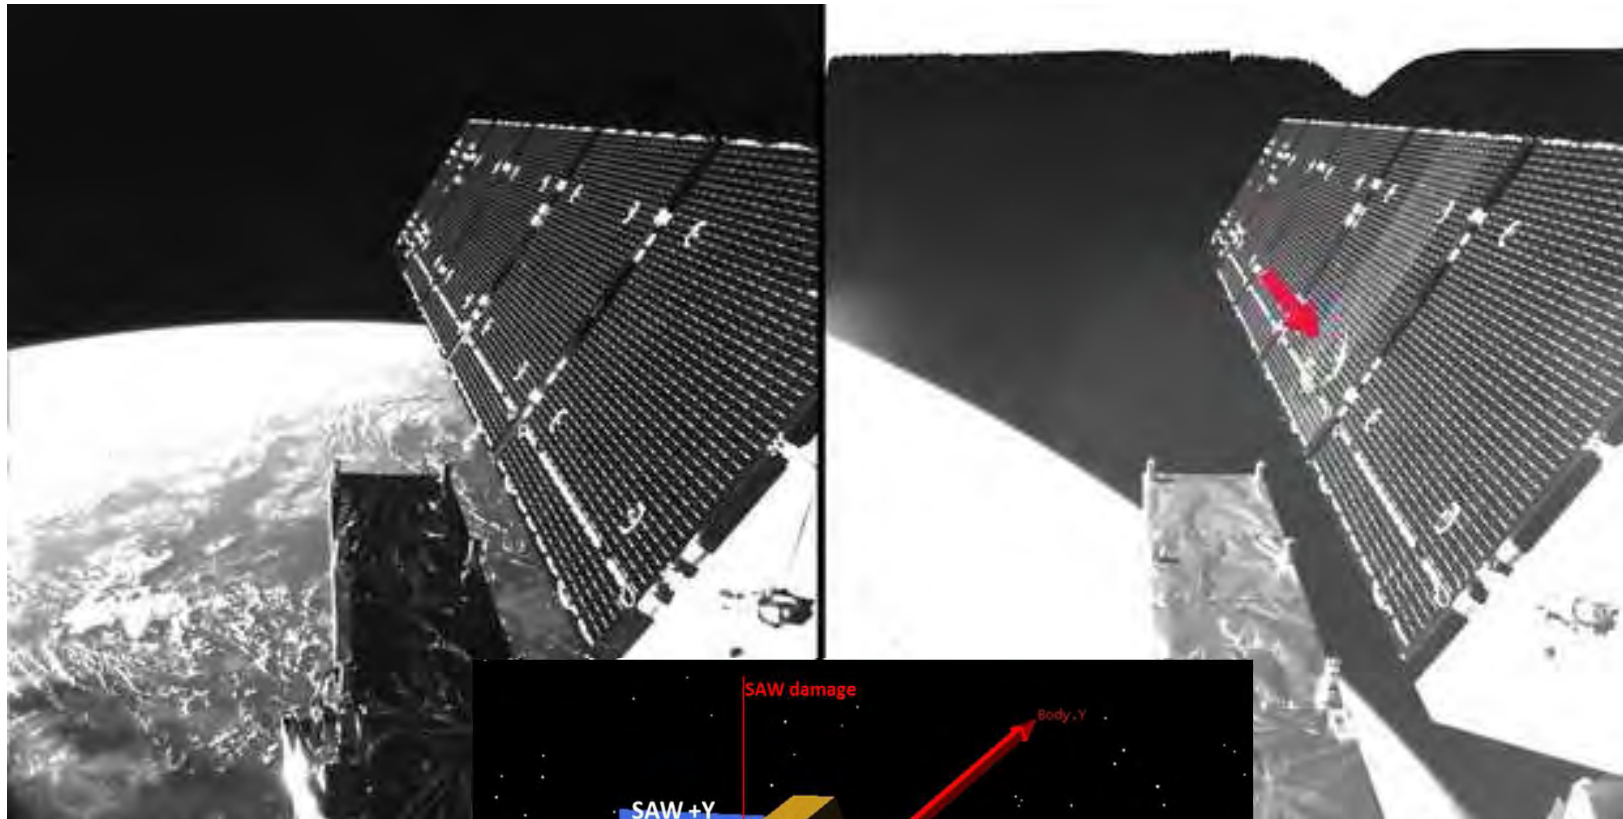
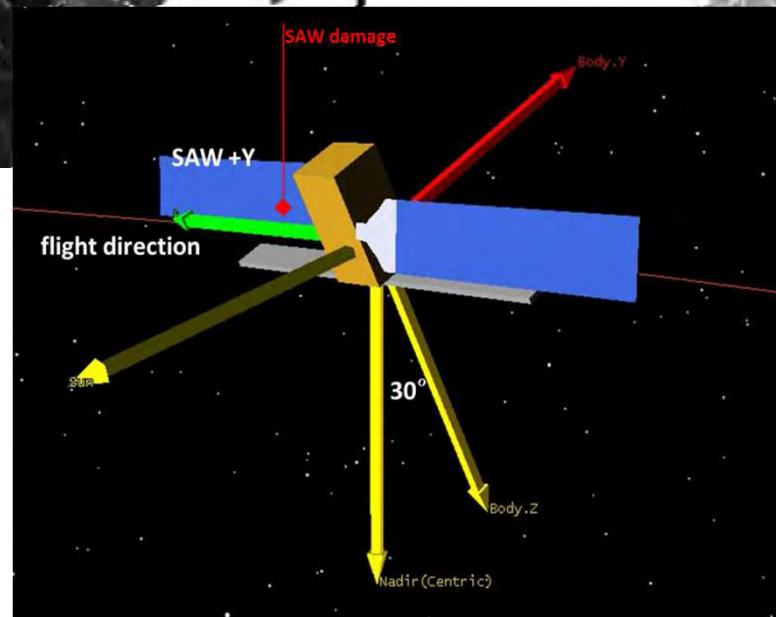
Sentinel-1A Impact 2016/08/23 – Onboard Camera

- The Sentinel-1A anomaly of 2016-08-23 17:07:37 UTC was caused by a hyper-velocity impact.
- Attitude and orbit changes, the type of observed damages, the impactor directionality and the latitude of the spacecraft at impact all point to man-made debris.

- The impact occurred onto the back side of the leading solar array (SAW +Y) under an approach angle along the horizontal plane with an off-angle of 45degree from flight direction.

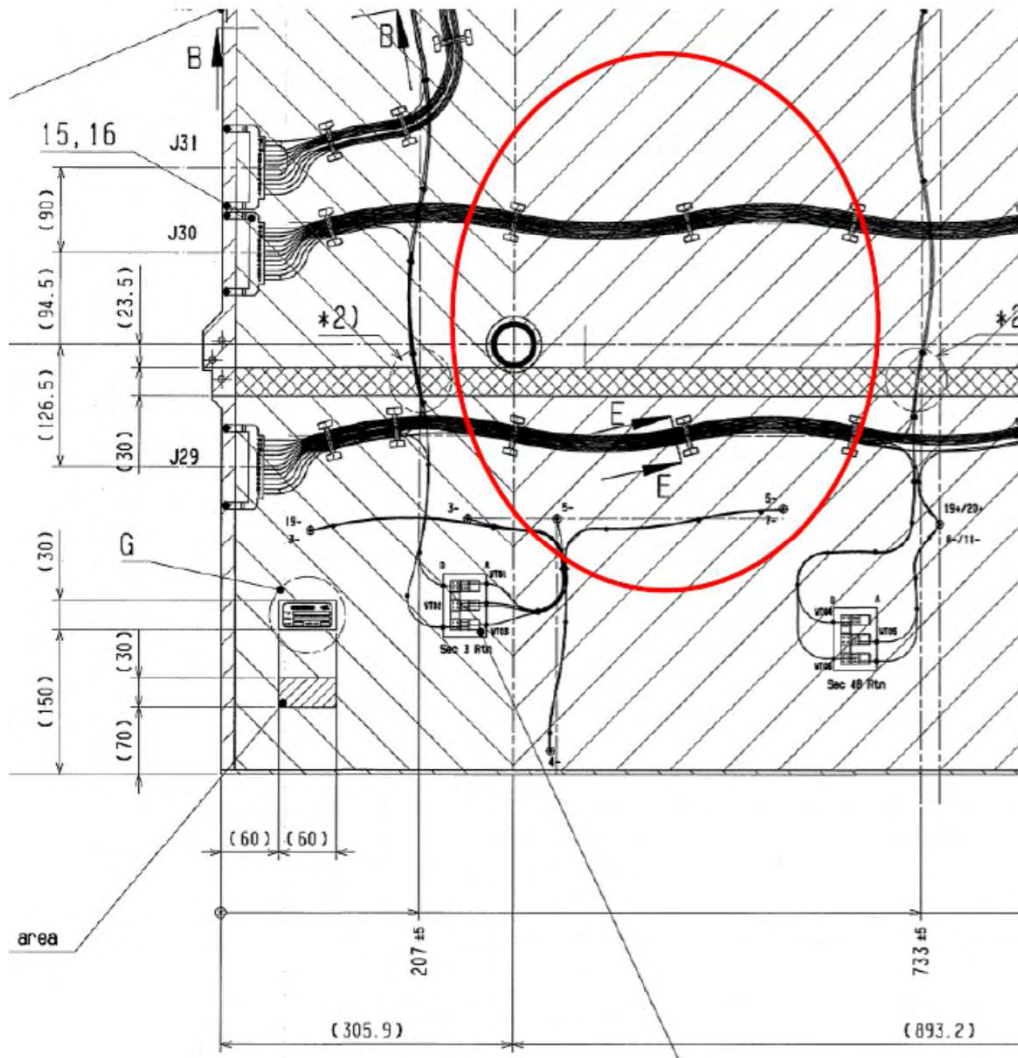
1mm 45deg rearside impact

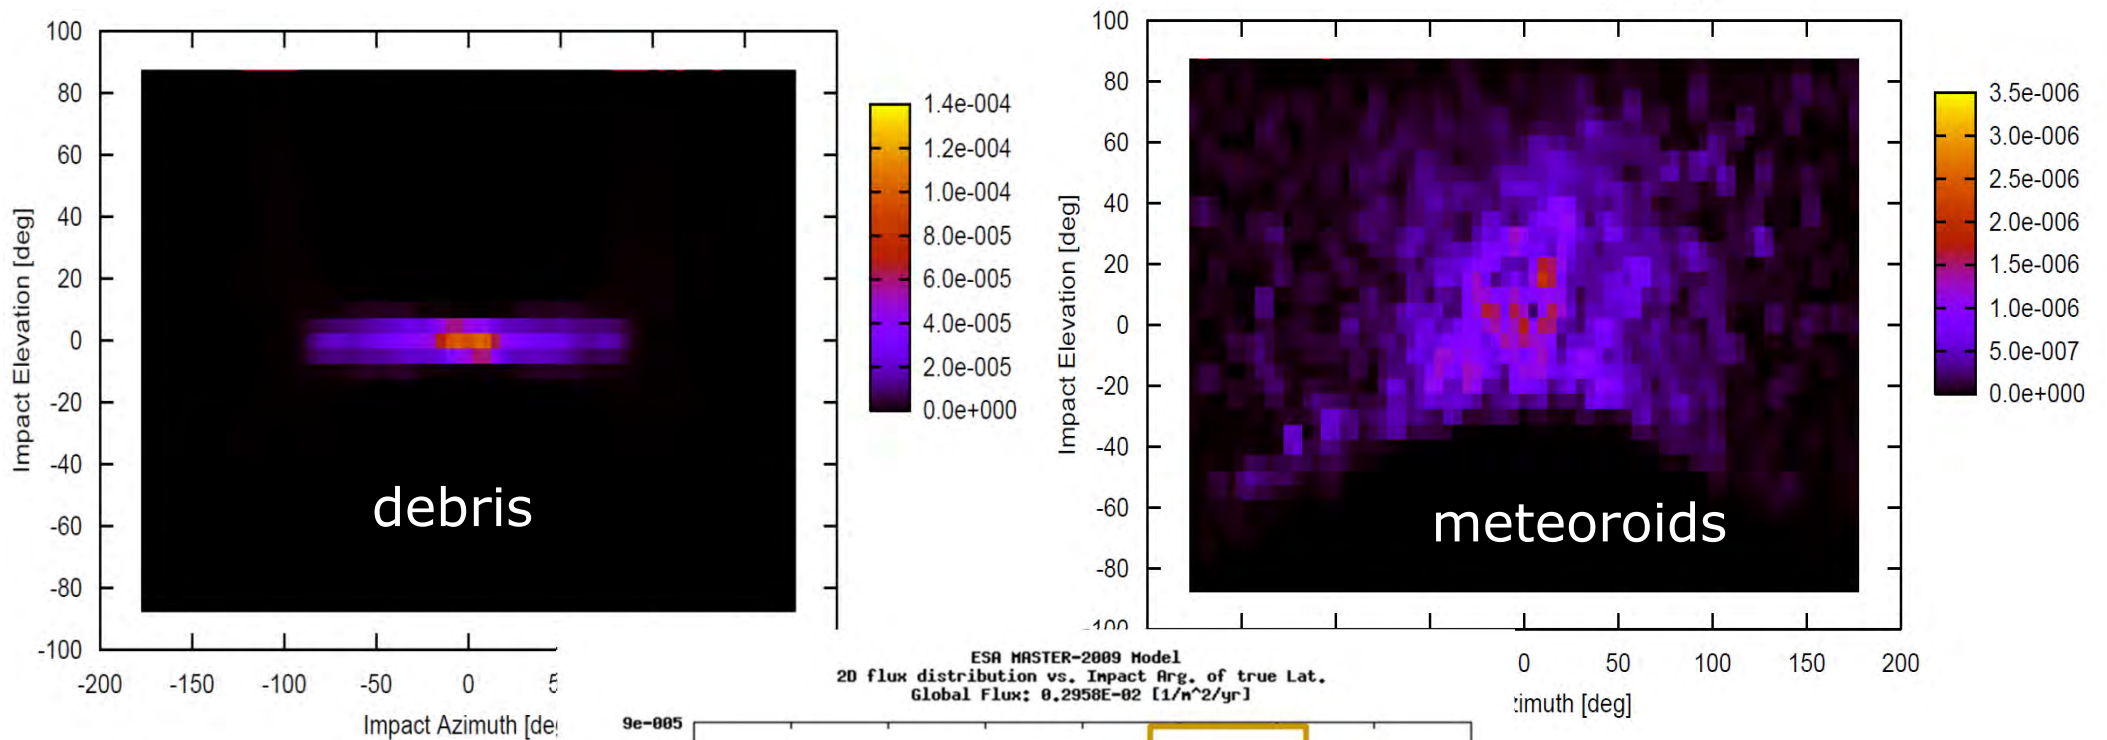
ESA MASTER-2009 Model
 2D flux distribution vs. Impact Arg. of true Lat.
 Global Flux: $0.2956E-02$ [$1/m^2/yr$]
