Sentinel-1A Solar Array Impact

Benjamin Bastida Virgili, Holger Krag, ESA Space Debris Office

21/03/2017

Sentinel-1A Impact 2016/08/23

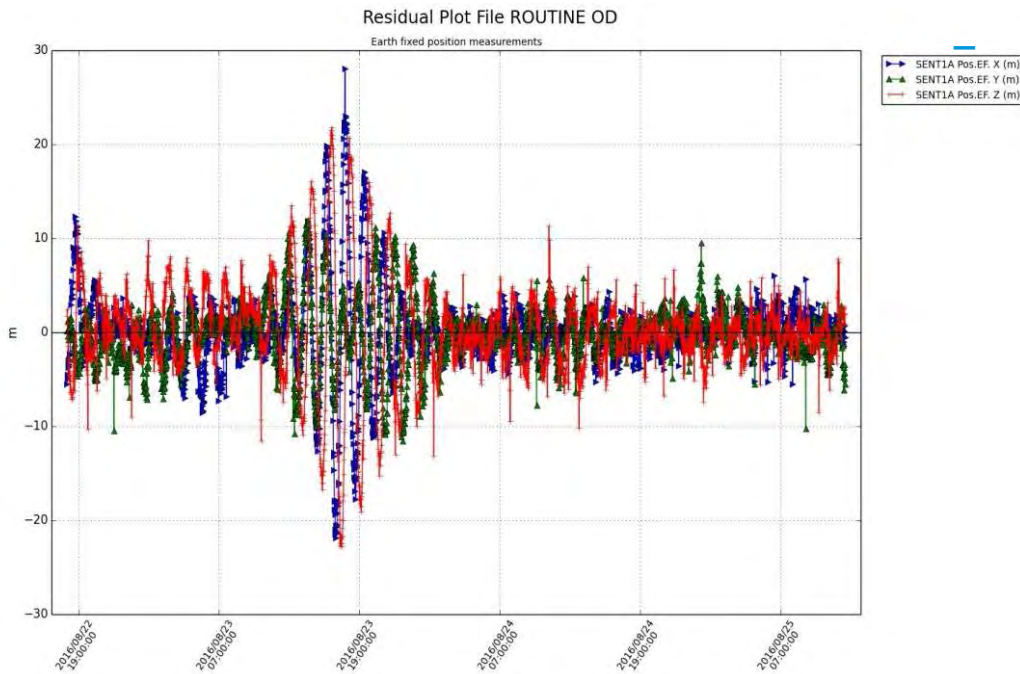
At around 17:07 UTC:

- Inconsistency in the GPS-based orbit solution
- Ad-hoc change in the wheel rates
- The output power of the SAW+Y Solar array dropped by 280W from a nominal 6000W on 2016/08/23 17:07:47 UTC

After analysis:

- Loss of about 5% solar array
- Orbit change by 0.7mm/s
- Attitude changed by a few degree
- USSTRATCOM tracks 8 fragments

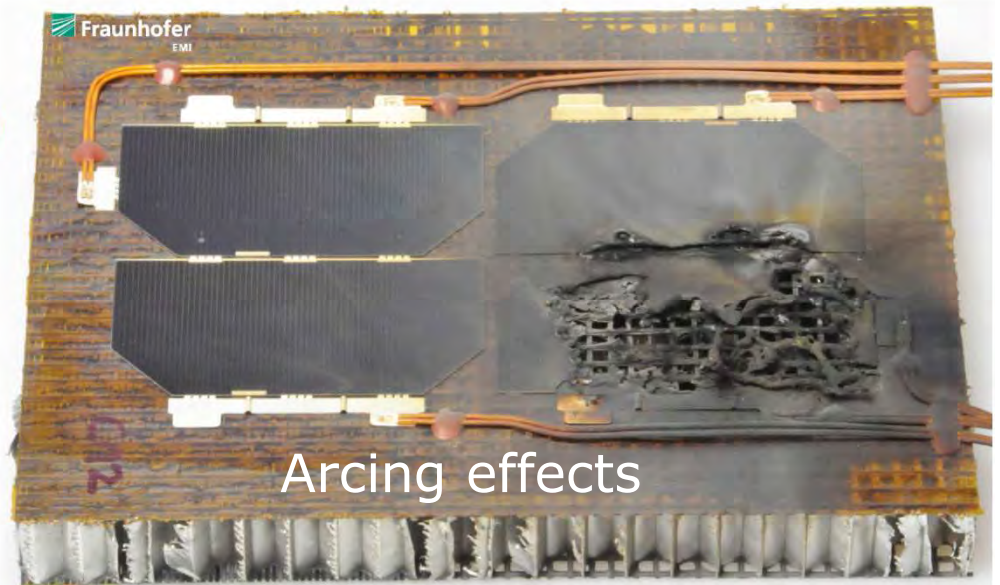
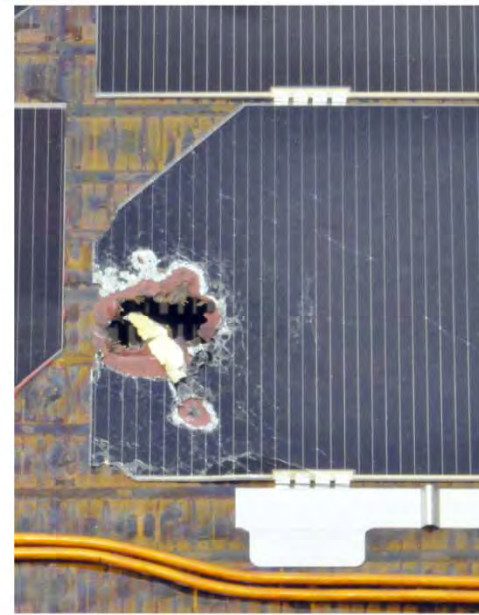
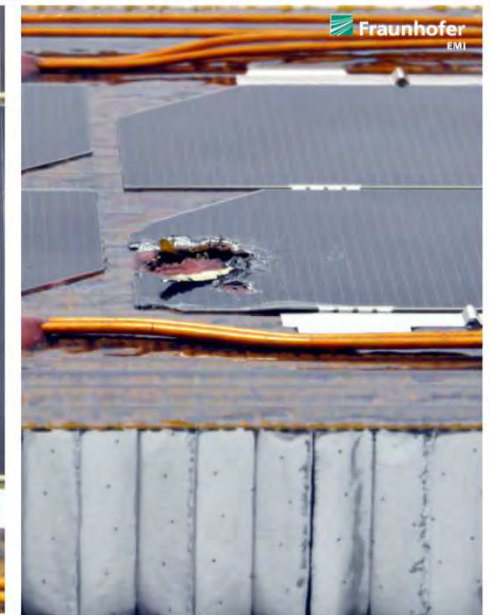
- The Sentinel-1A anomaly of 2016-08-23 17:07:37 UTC was caused by a hyper-velocity impact.
- Attitude and orbit changes, the type of observed damages, the impactor directionality and the latitude of the spacecraft at impact all point to man-made debris.

- With this, it is safe to conclude that a man-made piece of debris (most likely an explosion or collision fragment) of 0.2g mass and approximately 1cm size was the impactor. It approached with about 11km/s. Its equivalent diameter as an aluminium sphere would be about 5mm.

- The impact occurred onto the back side of the leading solar array (SAW +Y) under an approach angle along the horizontal plane with an off-angle of 45degree from flight direction.

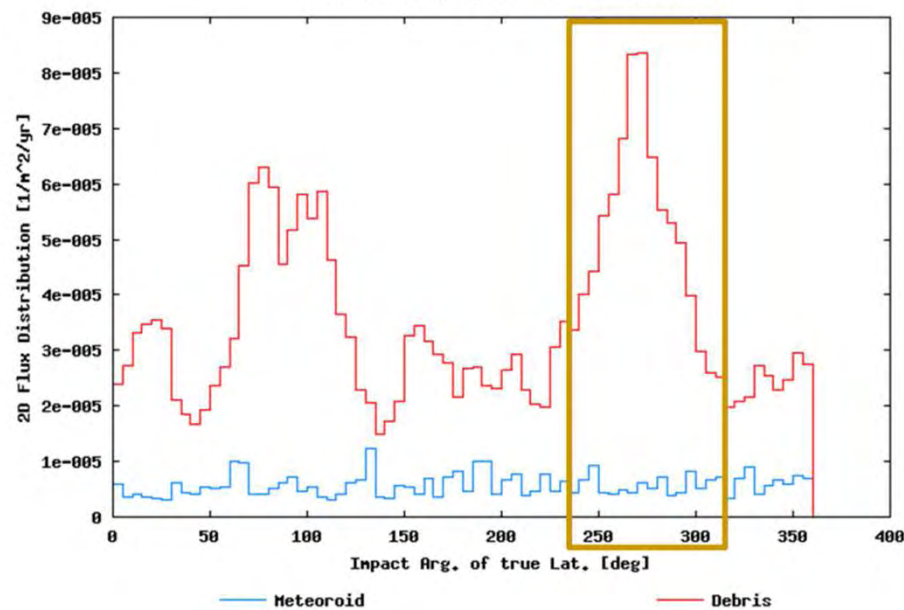
ESA MASTER-2009 Model
 2D flux distribution vs. Impact Arg. of true Lat.
 Global Flux: $0.2956E-02$ [$1/m^2/yr$]
